Exhibit 2: Stuart Creek Fish Barrier Photographs

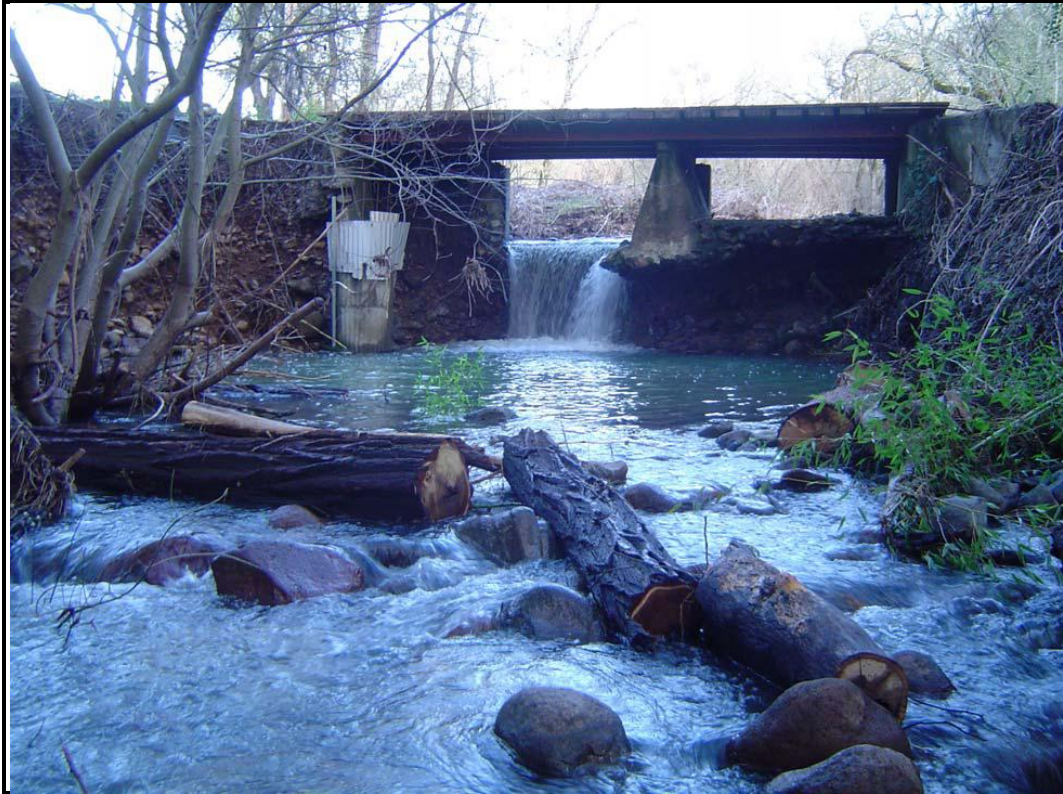
View of the bridge box culvert from downstream on the Stuart Creek Run property.

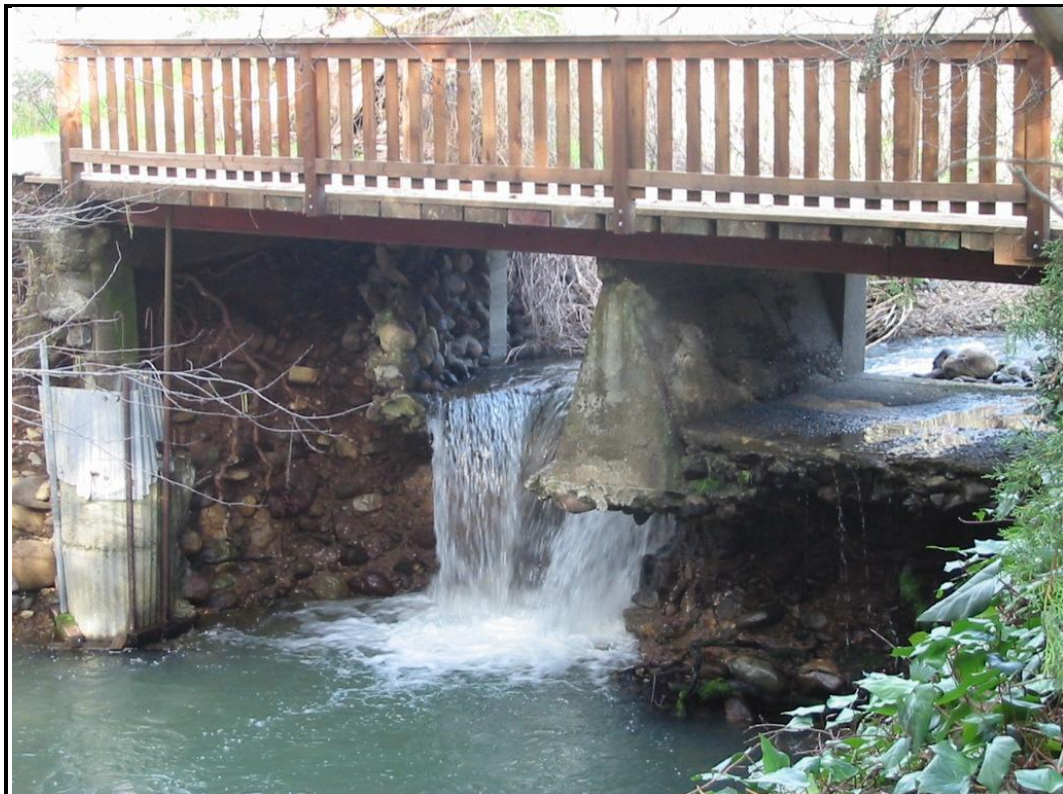
Close-up view of failing bridge box culvert at Stuart Creek Run taken in Fall 2008.

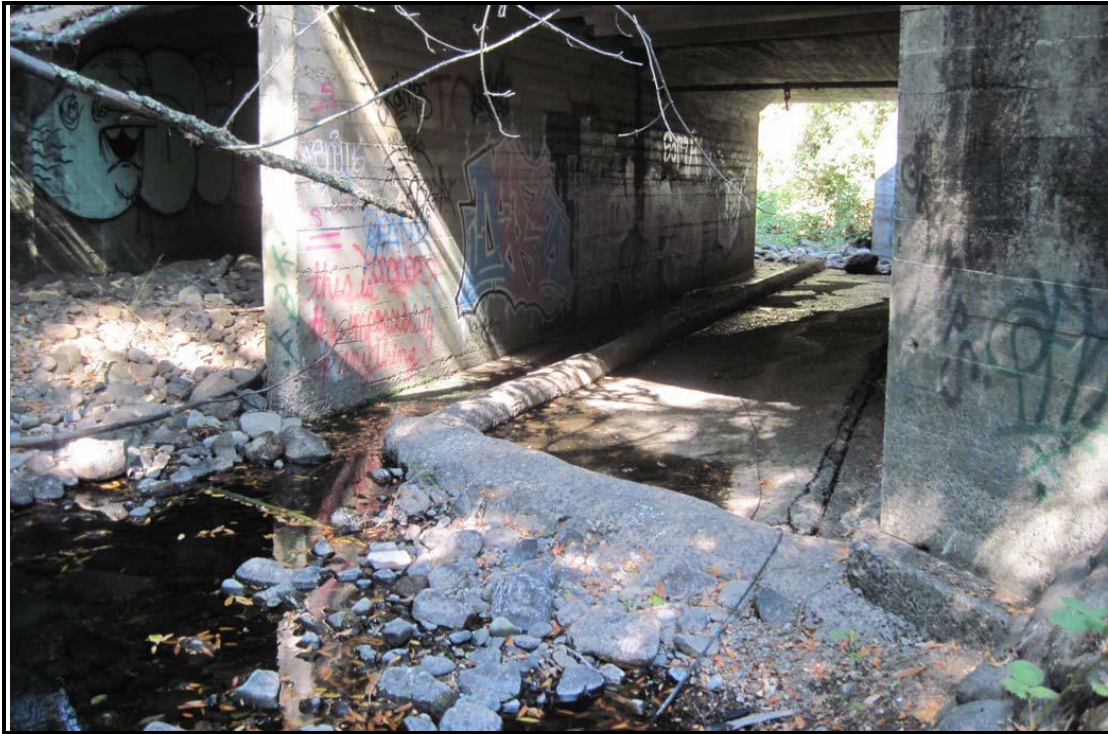
View of the Arnold Drive box culvert taken from upstream on Stuart Creek.

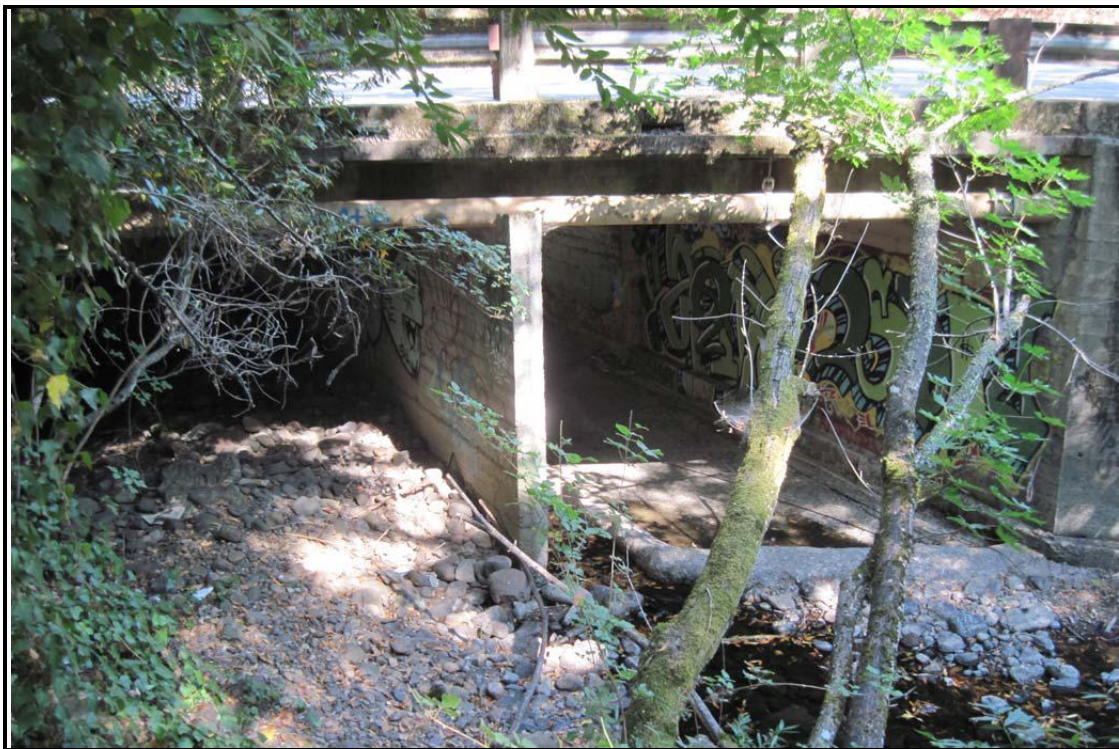
View of the Arnold Drive box culvert taken from downstream on Stuart Creek.

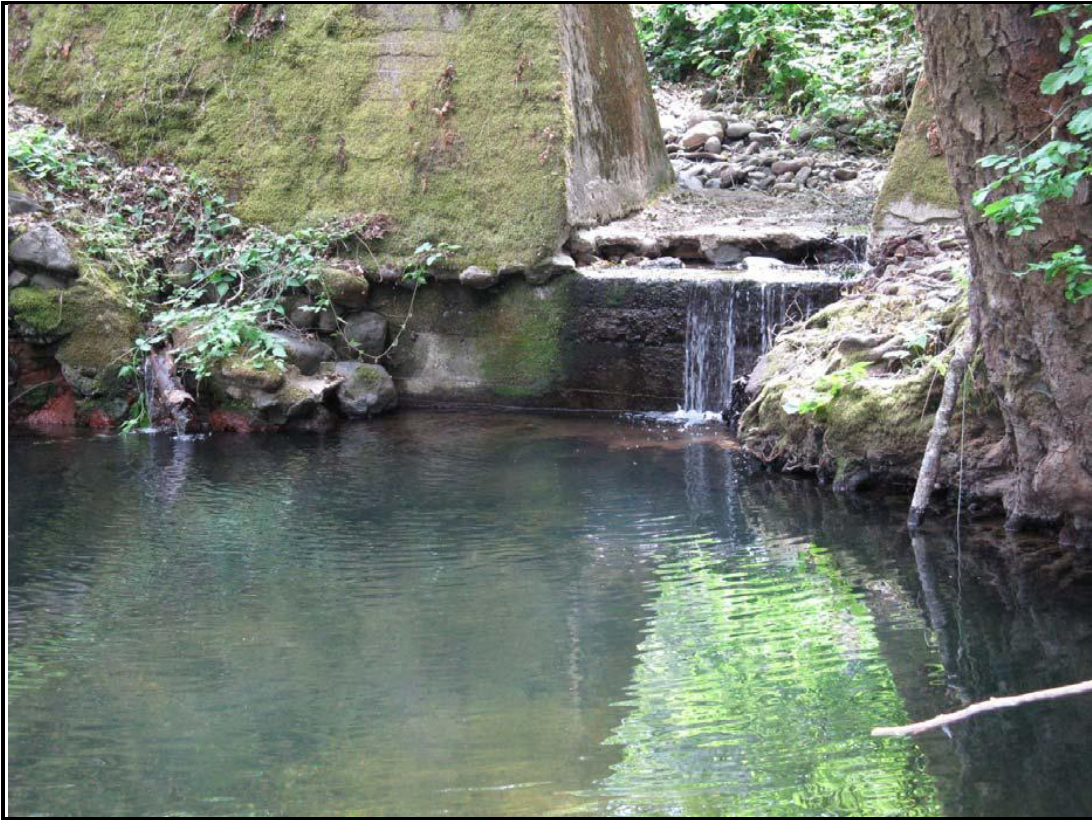
View upstream at Glen Oaks Ranch flashboard dam with 2.5-foot drop from spillway.

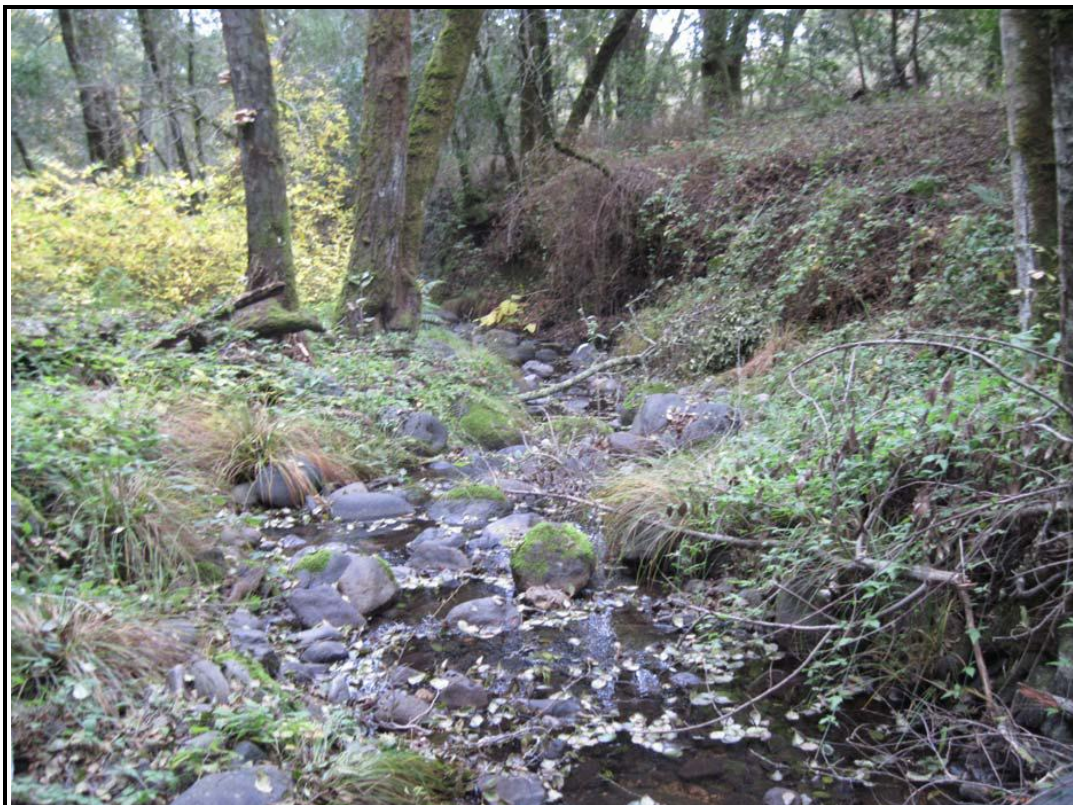
View from below the Glen Oaks Ranch dam downstream toward Stuart Creek Run.
